**HRS DOCUMENTATION RECORD COVER SHEET****Name of Site:** Lane Street Ground Water Contamination**EPA ID No.:** INN000510229**Contact Persons**

## HRS DOCUMENTATION RECORD

Name of Site: Lane Street Ground Water Contamination

Date Prepared: March 2009

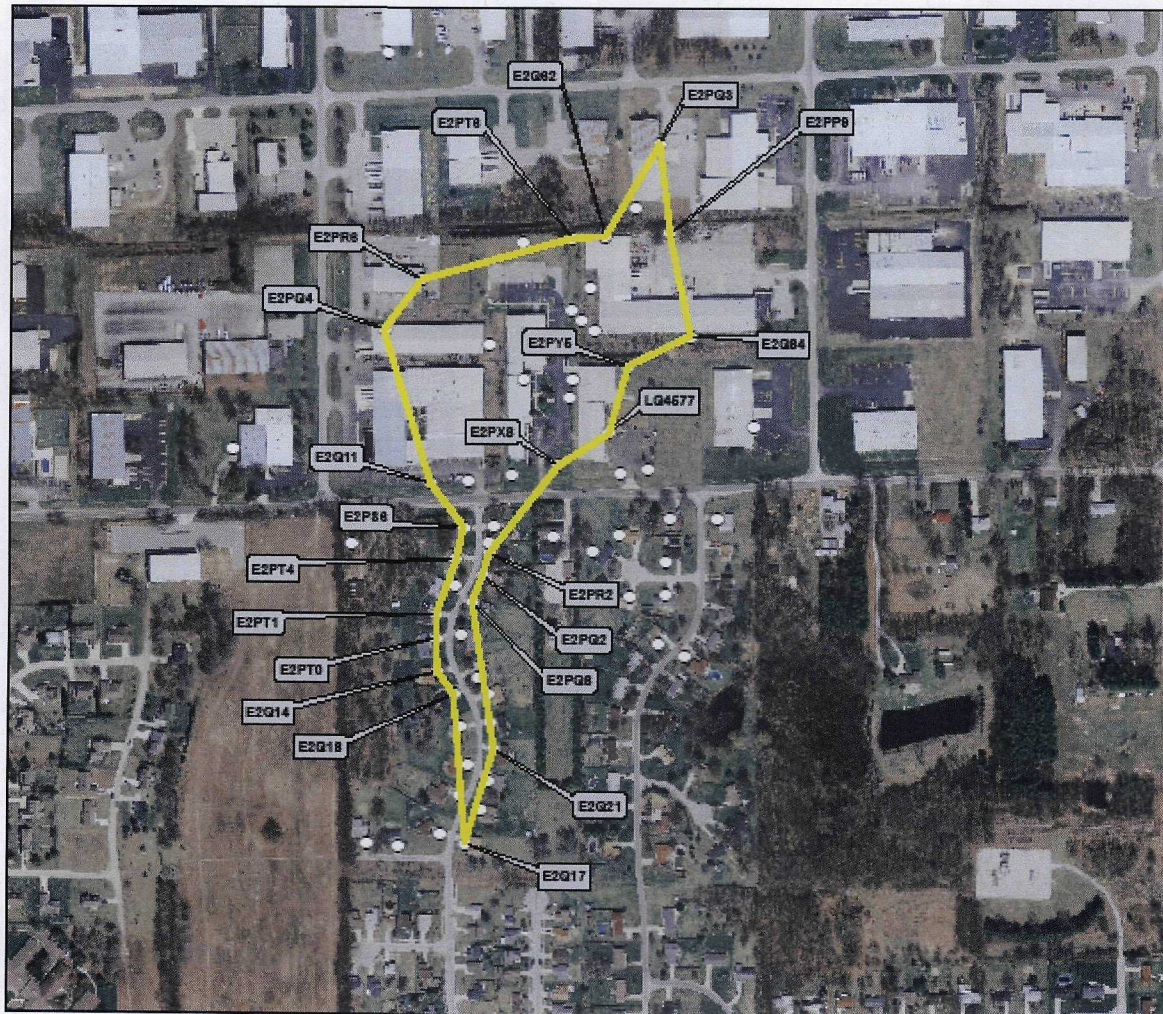
**Lane Street Ground Water Plume Boundary Map**  
**Defined by Chlorinated VOC's from Key Findings List &**  
**Preliminary Assessment Ground Water Sampling Results**  
**Elkhart, Elkhart County, IN**  
**EPA ID: INN000510229**

- Sample Locations
- Lane Street Ground Water Plume Boundary
